Coatings Research Institute

Procedure for the Fixing and Encapsulation of Asbestos Fibres on Weathered Asbestos Cement by Dakfill

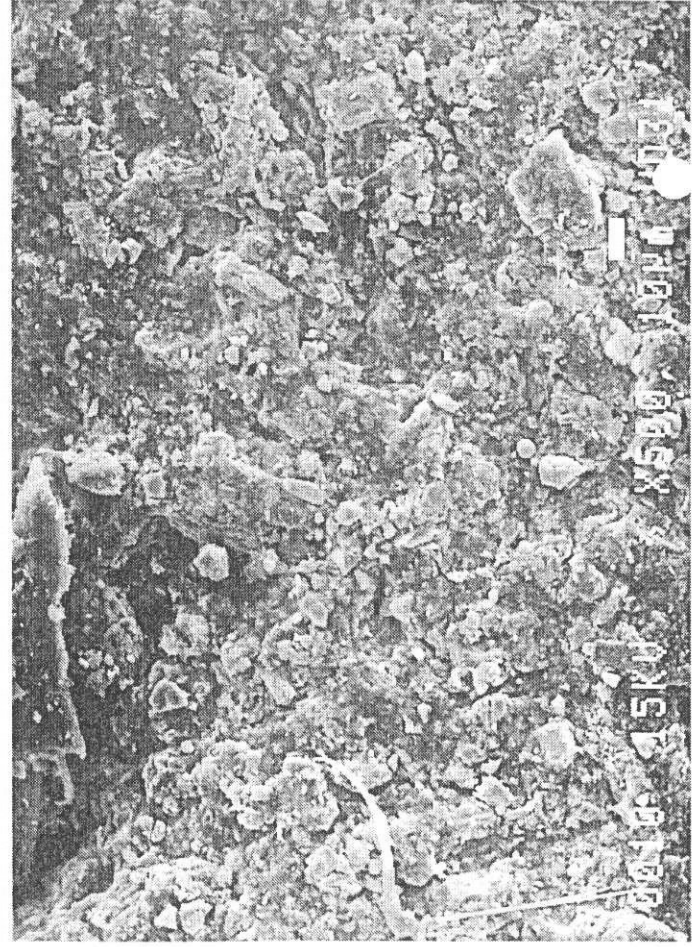
- 0010 paint system 1 after QUV
- 0100 paint system 1 after Kesternich
- 1000 paint system 1 after immersion in acid bath
- 0500 naked asbestos cement before Kesternich
- 5000 naked asbestos cement before immersion in acid bath
- 0400 naked asbestos cement after Kesternich
- 4000 naked asbestos cement after immersion in acid bath
- 1101 cross-section paint system 1
- 0401 asbestos fibre on diaphragm filter
- 0402 asbestos fibre on diaphragm filter
- 0403 asbestos fibre on diaphragm filter
- 0404 asbestos fibre on diaphragm filter
- 0405 asbestos fibre on diaphragm filter
- 0406 asbestos fibre on diaphragm filter
